## GE Vernova Shares How a Custom-Built, Large-Capacity Runout Inspection Table Helped Speed Up Rotor Repair & Assembly

**GE Vernova teamed up with ABTech to create a custom-built, large-capacity rotary table with 0.25  $\mu\text{m}$  accuracy.**

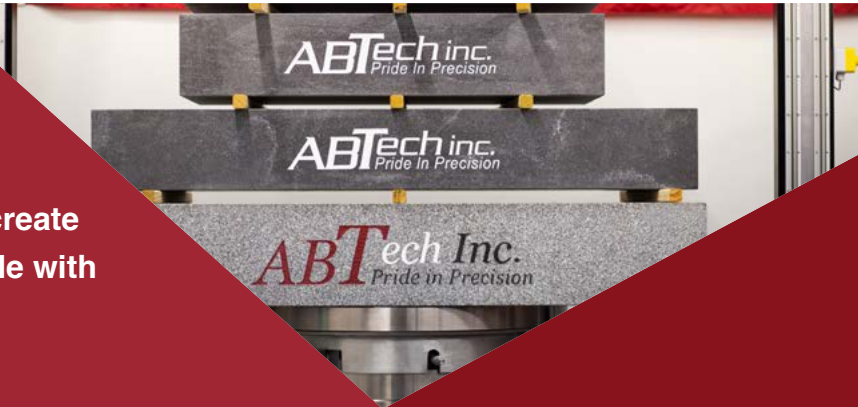
ABTech designed and constructed a rotary table with an impressive three-foot granite platform foundation; it supported a 35,000-lb load and offered a 0.25  $\mu\text{m}$  rotational accuracy. The table’s hydrostatic oil film bearing technology was key to achieving the required high load capacity, extreme stiffness, and ultra-smooth sub-micron motion.
