## GE Vernova Shares How a Custom-Built, Large-Capacity Runout Inspection Table Helped Speed Up Rotor Repair & Assembly

**GE Vernova teamed up with ABTech to create a custom-built, large-capacity rotary table with 0.25  $\mu\text{m}$  accuracy.**

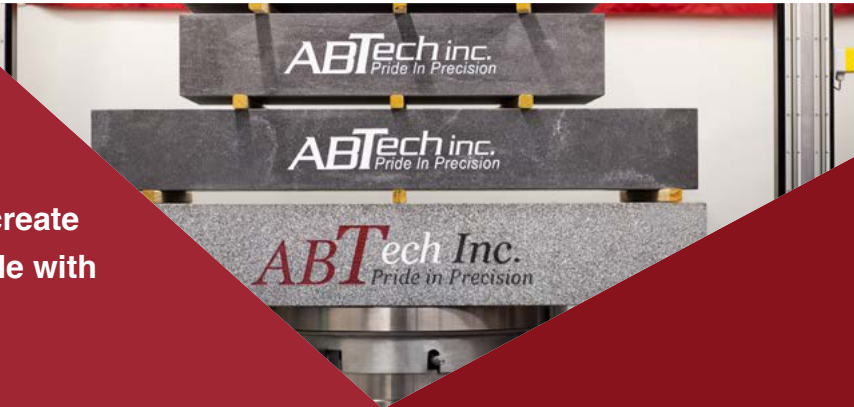
ABTech designed and constructed a rotary table with an impressive three-foot granite platform foundation; it supported a 35,000-lb load and offered a 0.25  $\mu\text{m}$  rotational accuracy. The table’s hydrostatic oil film bearing technology was key to achieving the required high load capacity, extreme stiffness, and ultra-smooth sub-micron motion.

GE could use the new rotary table to check the roundness and flatness of large-scale turbine parts, which helps determine how to position individual components in order to assemble a rotor as close to truly straight as possible.

By collaborating with ABTech, GE ensured the rotary table could merge with the newly built inspection measurement arms. Joining these two technologies—ABTech’s high-capacity rotary table and the measurement arms—gave GE a dedicated run out inspection table for streamlining their turbine repair & assembly process.
